Technical Report CERC-96-8
September 1996

Periodic Inspection of Burns Harbor North Breakwater, Indiana

Report 1 Base Conditions

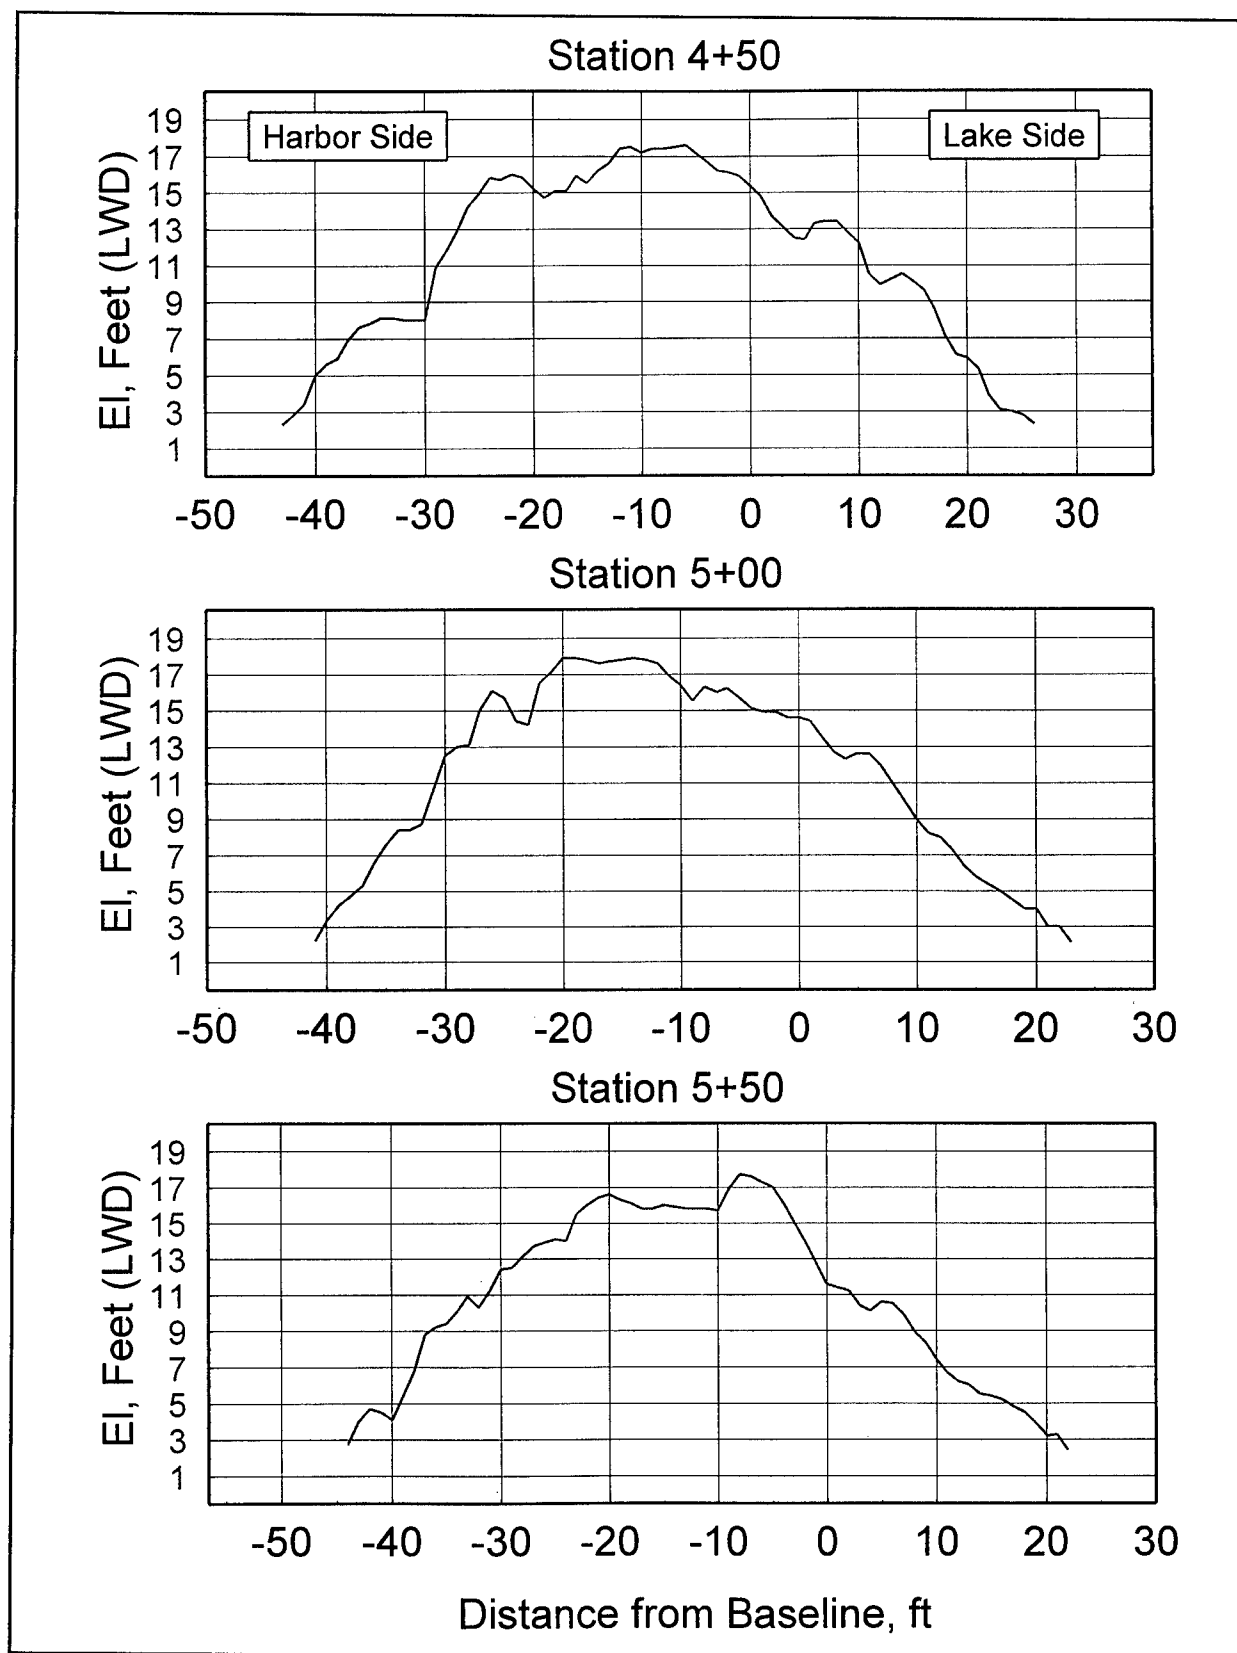
Figure B8. Cross sections of Burns Harbor North Breakwater, sta 4+50, 5+00, and 5+50

This appendix presents cross sections of the Burns Harbor North Breakwater. Cross sections were developed using the digital terrain model (DTM) grid as stated in the main text of this report. They were obtained at 0.3-rad (15-deg) intervals around the head of the breakwater and 15.2-m (50-ft) intervals along the trunk as shown in Figure 10 in the main text of this report. Elevations shown are in feet referred to low water datum (lwd). To convert them to meters, multiply by 0.3048. Distances from the baseline also are shown in feet and may be converted to meters using the same factor. The baseline established was the approximate center line of the breakwater. Negative distances are measured relative to the harbor side of the baseline and positive distances are measured relative to the lake side of the baseline.

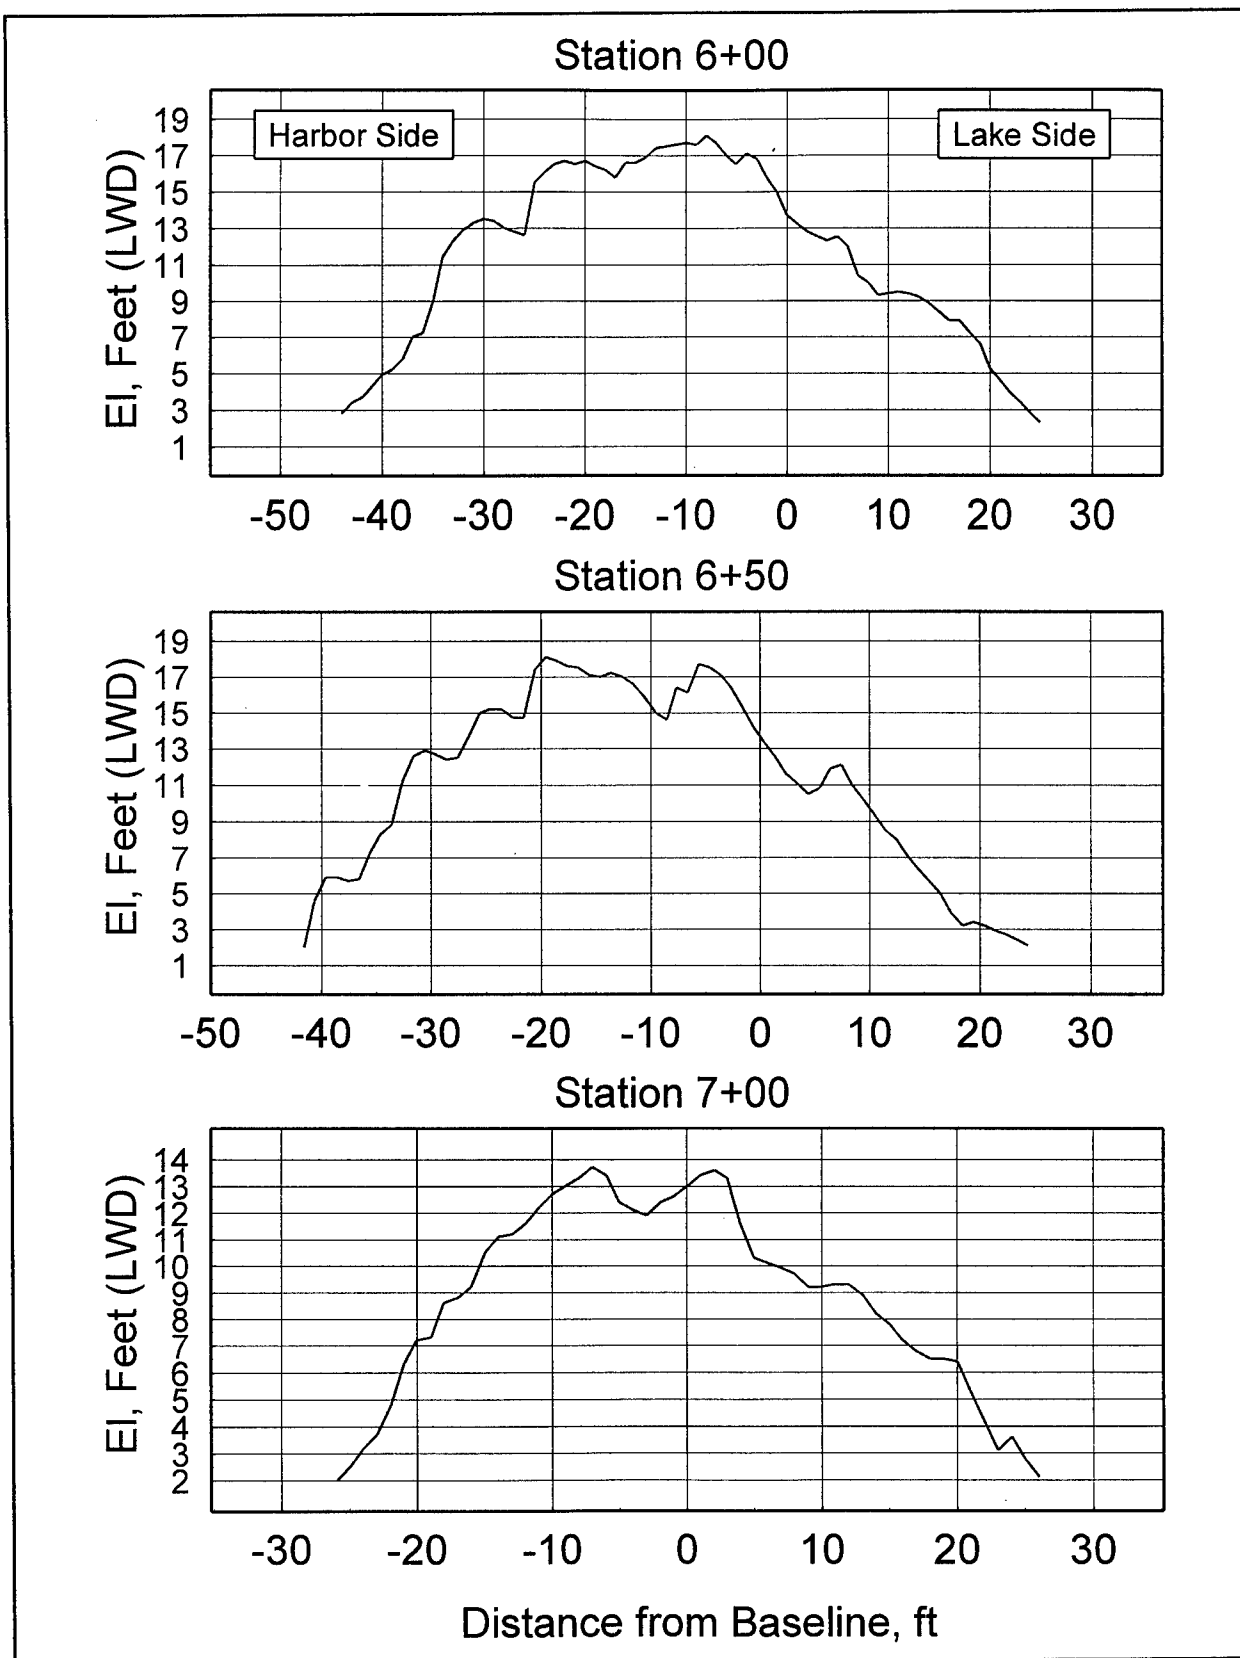
Figure B9. Cross sections of Burns Harbor North Breakwater, sta 6+00, 6+50, and 7+00

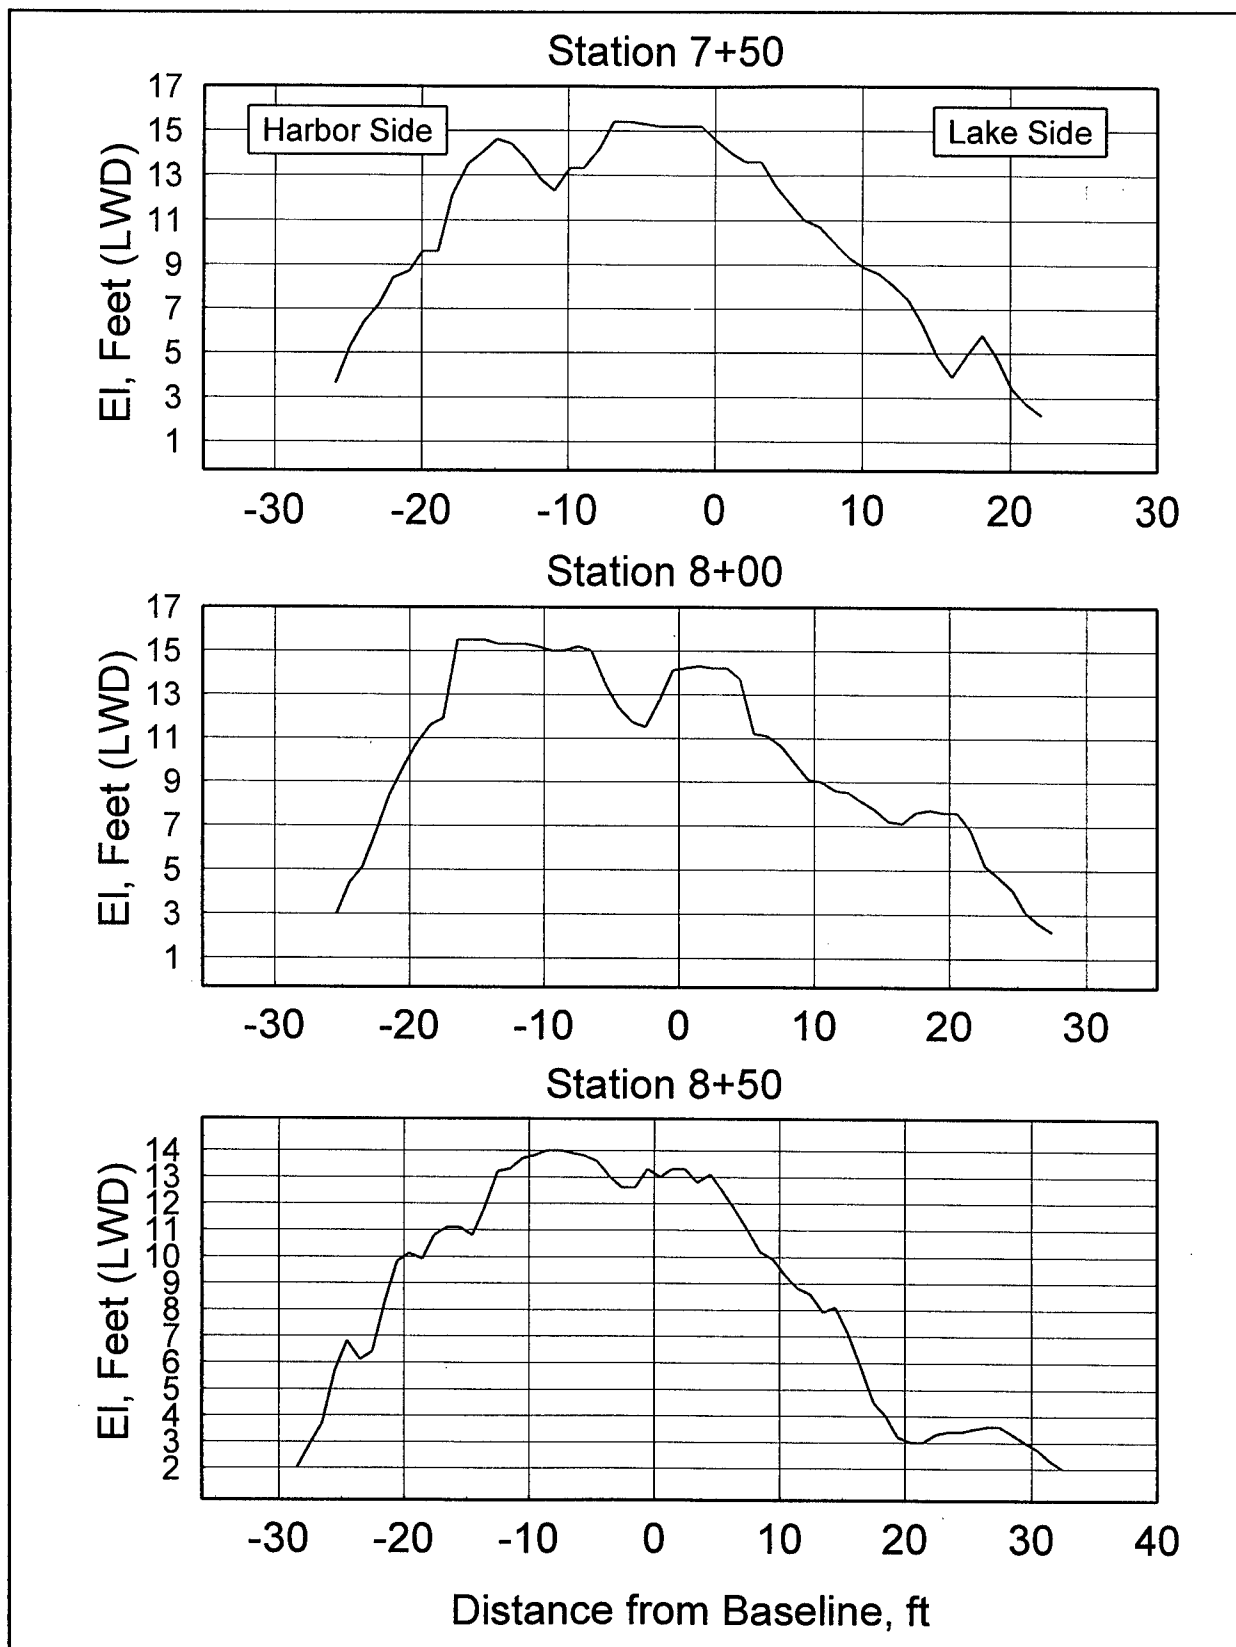
Figure B10. Cross sections of Burns Harbor North Breakwater, sta 7+50, 8+00, and 8+50

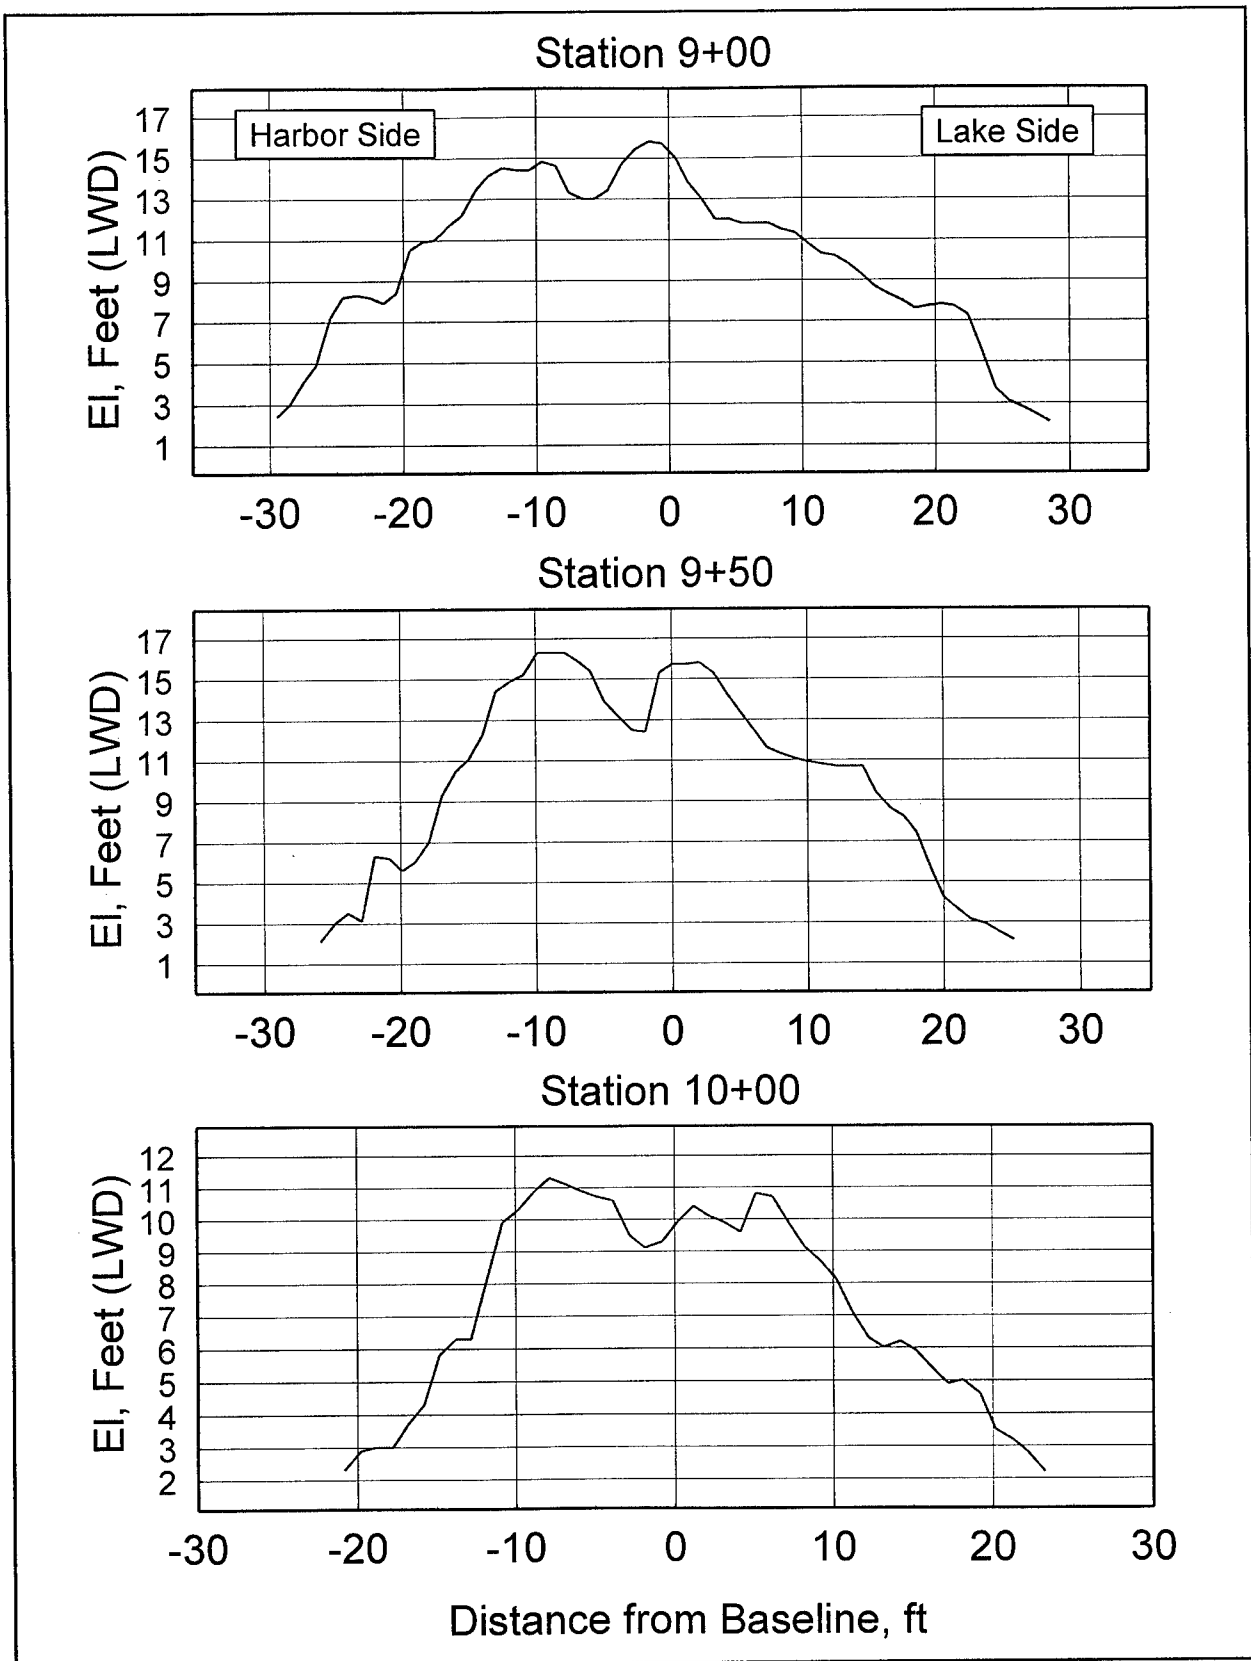
Figure B11. Cross sections of Burns Harbor North Breakwater, sta 9+00, 9+50, and 10+00

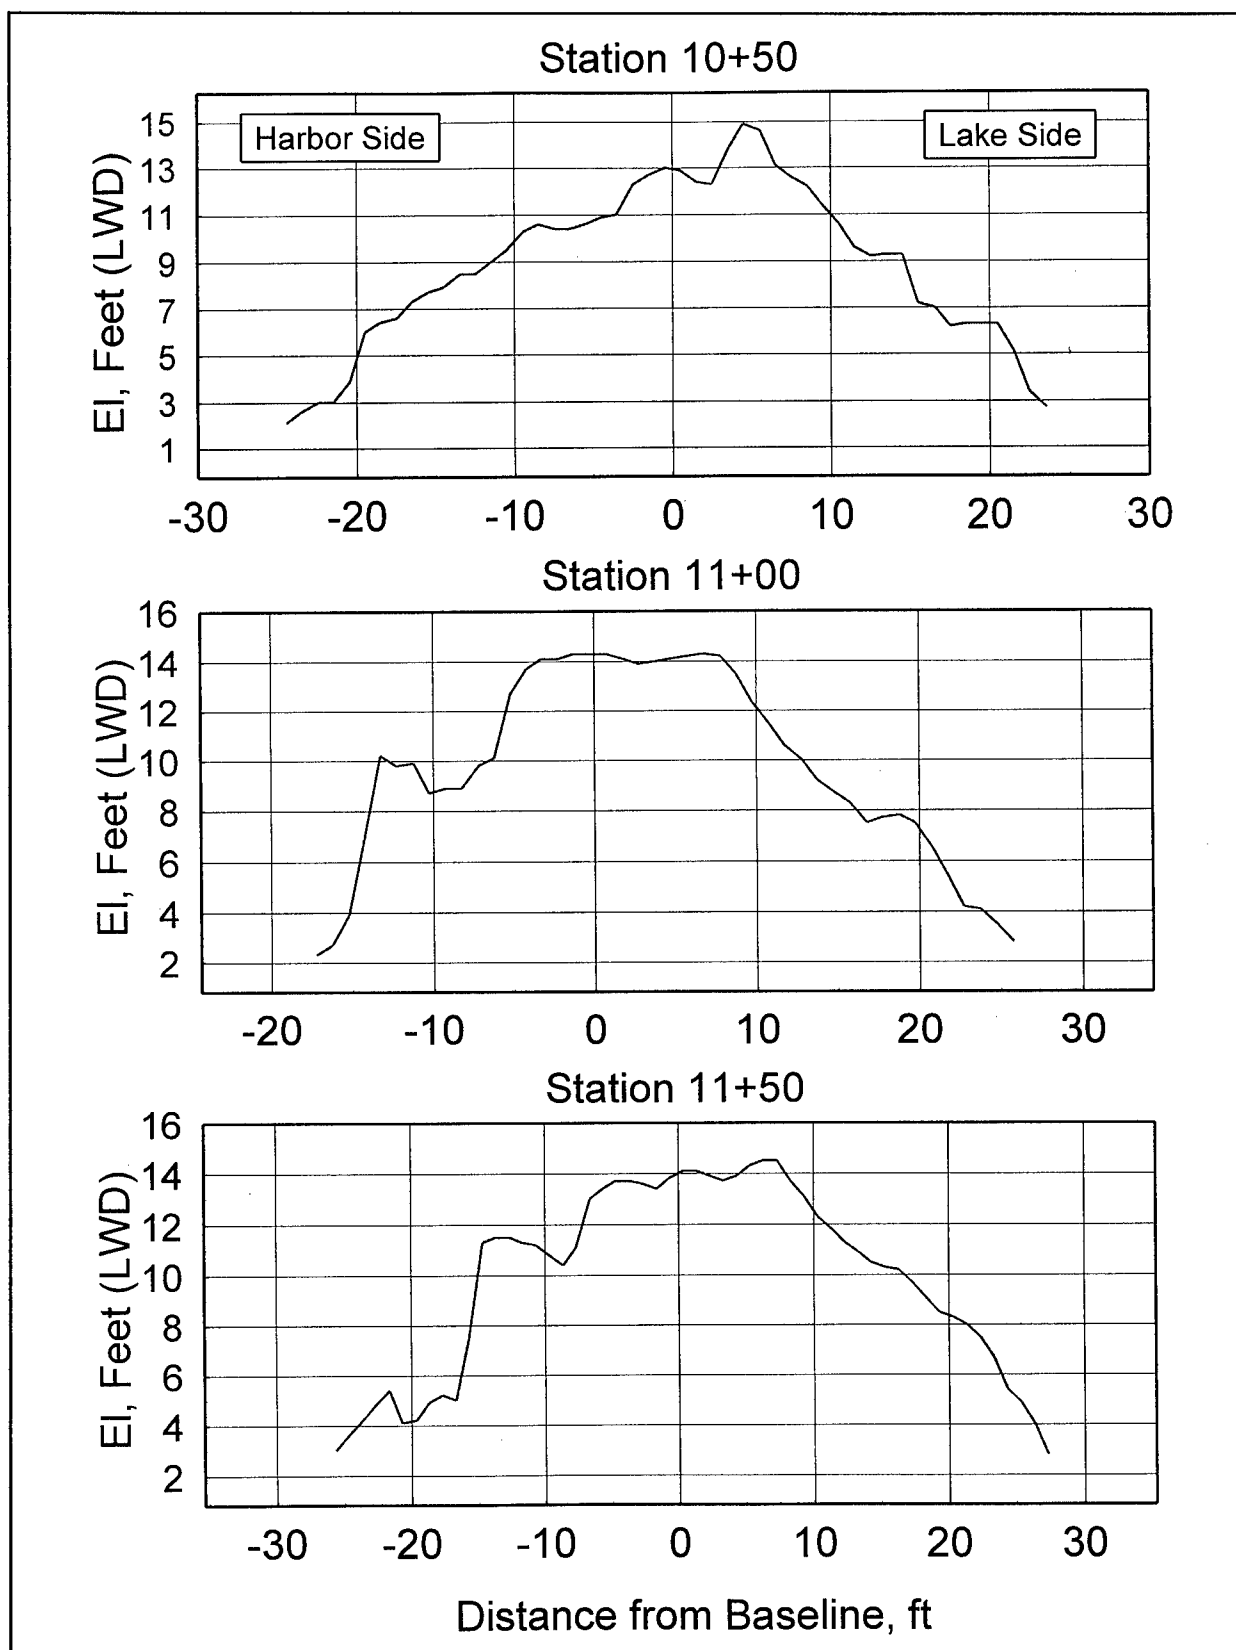
Figure B12. Cross sections of Burns Harbor North Breakwater, sta 10+50, 11+00, and 11+50

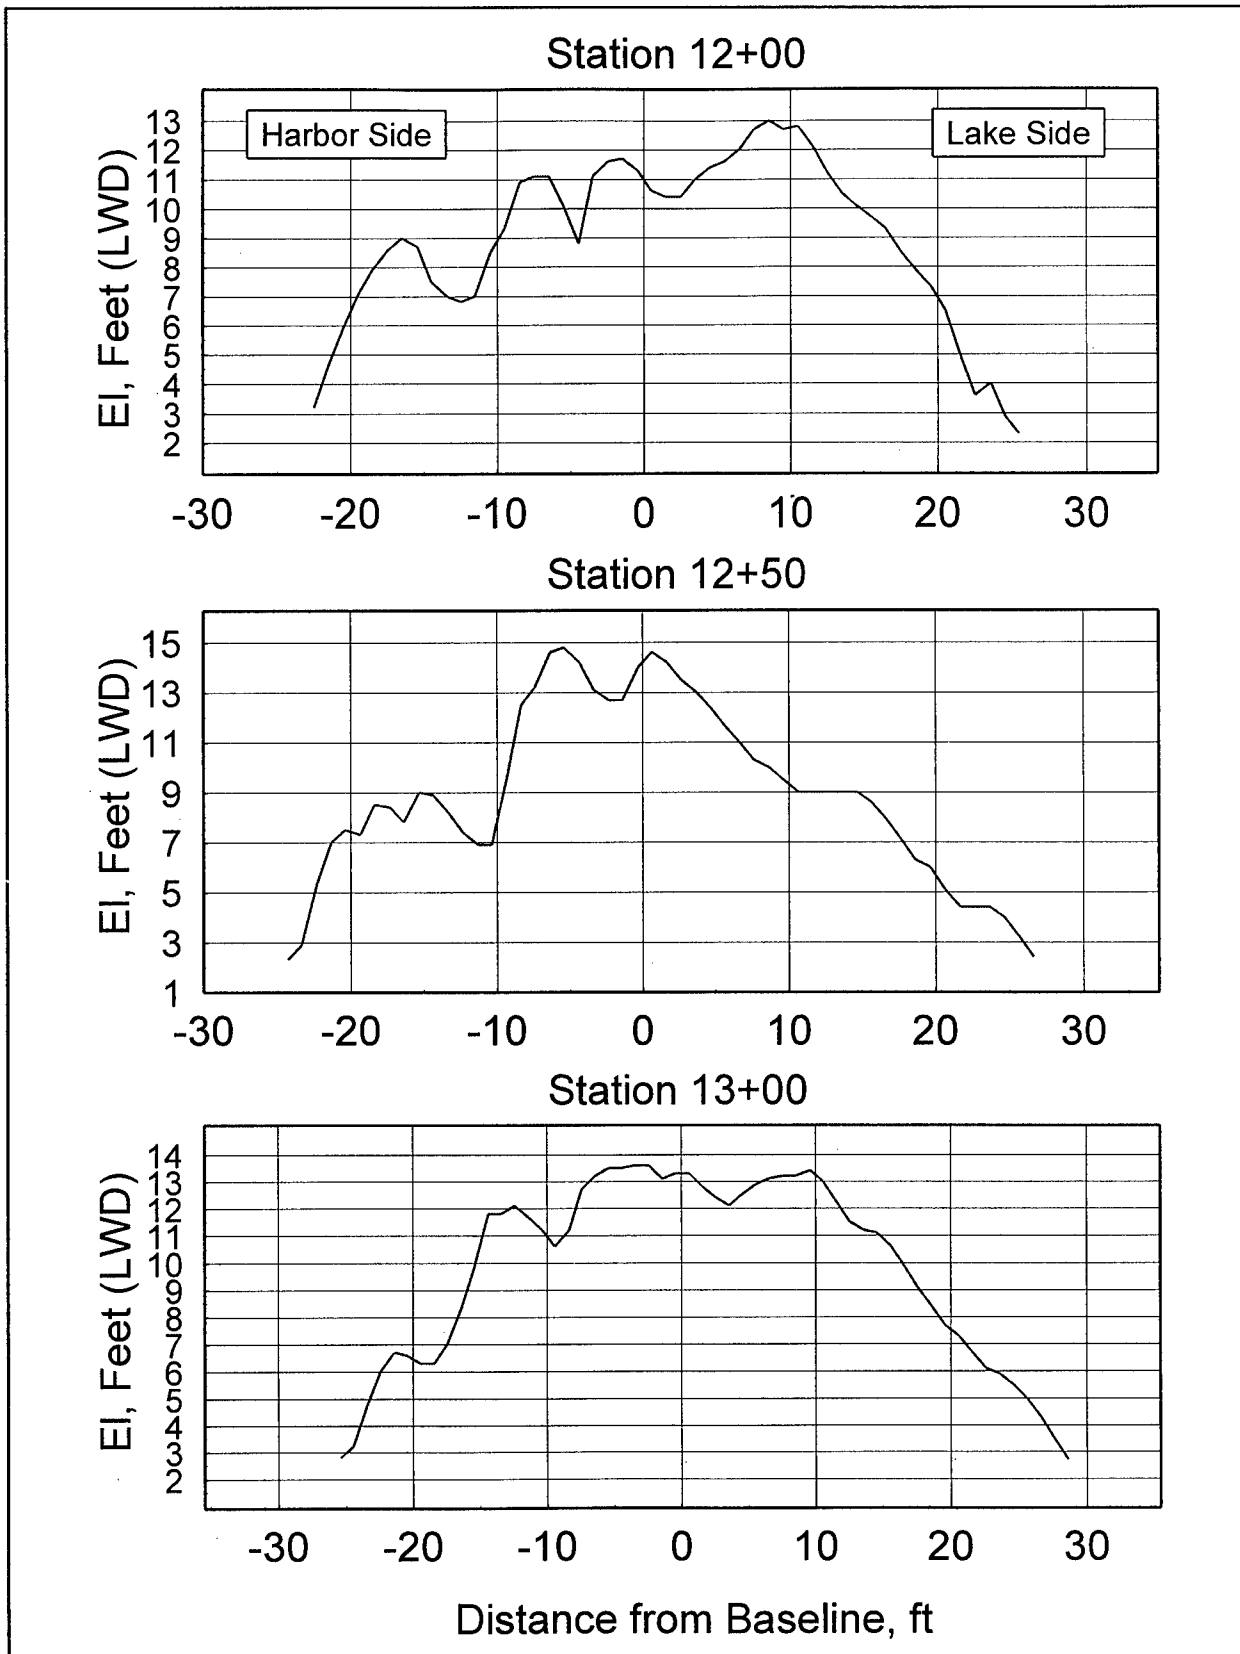
Figure B13. Cross sections of Burns Harbor North Breakwater, sta 12+00, 12+50, and 13+00

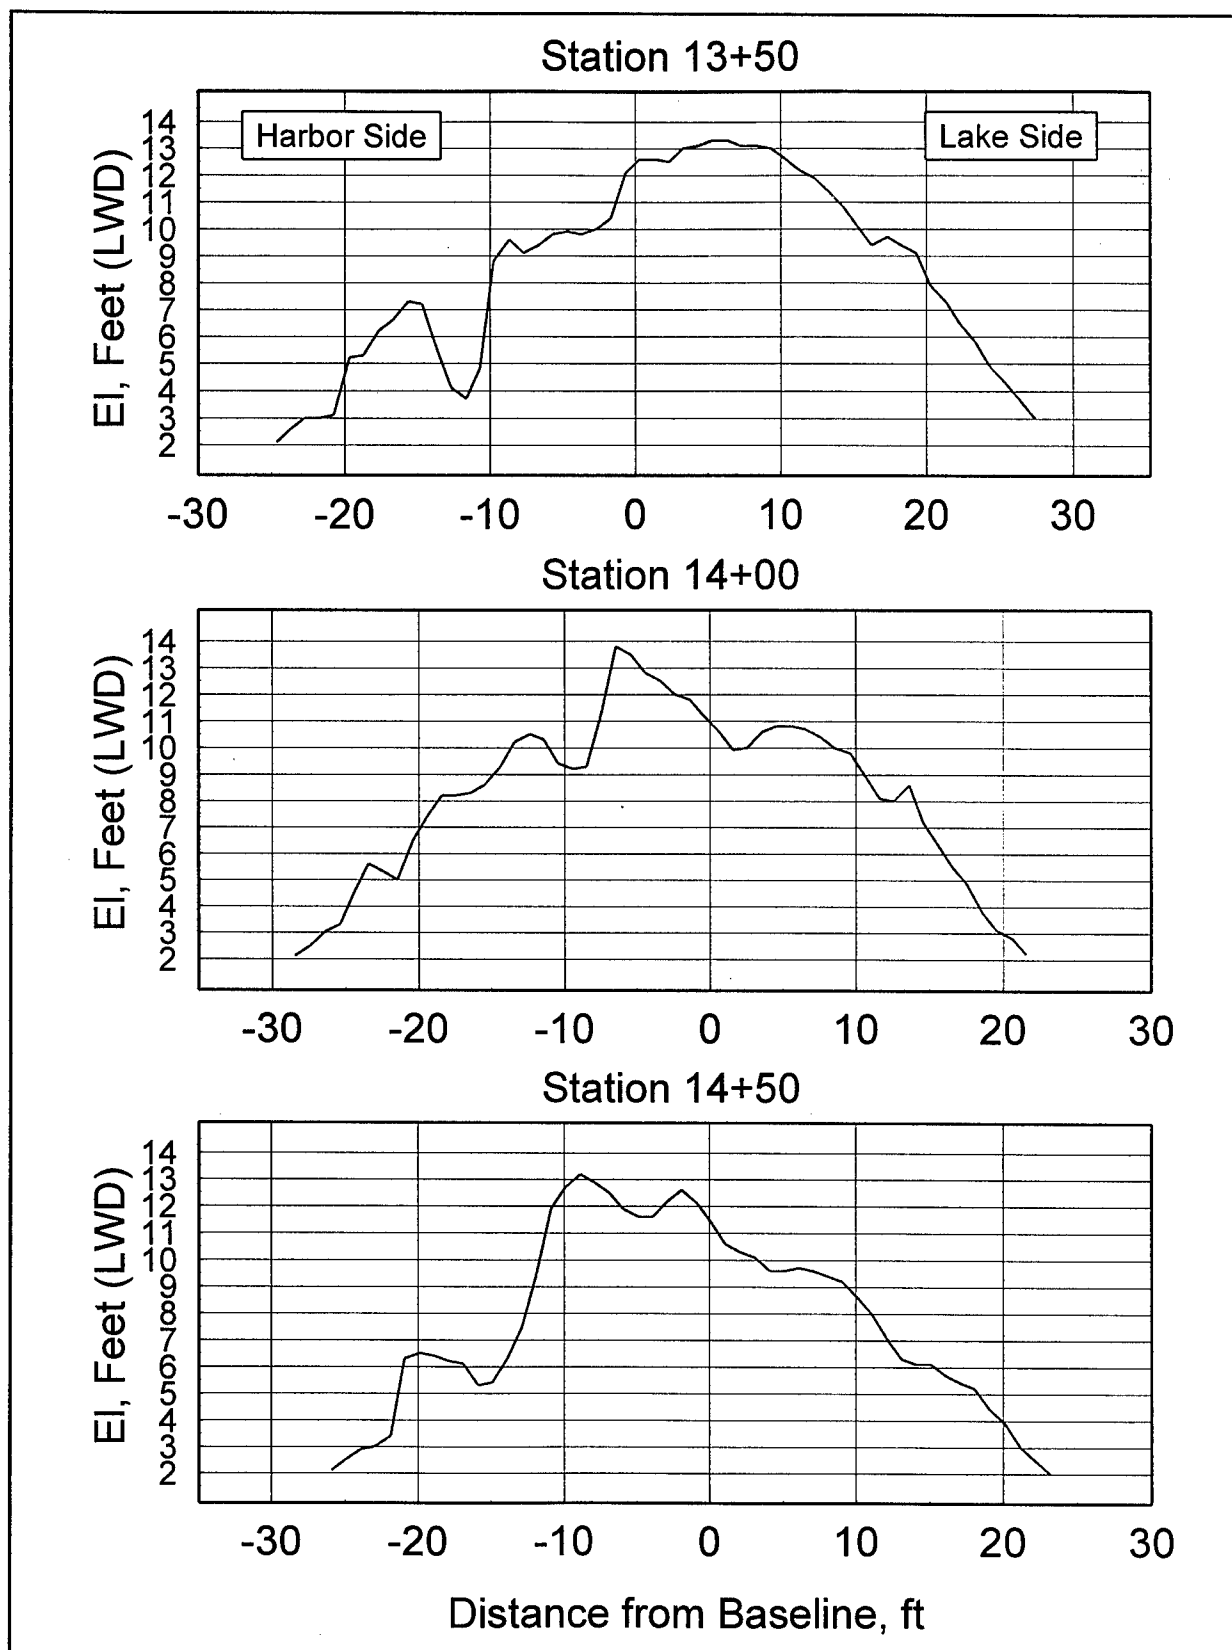
Figure B14. Cross sections of Burns Harbor North Breakwater, sta 13+50, 14+00, and 14+50

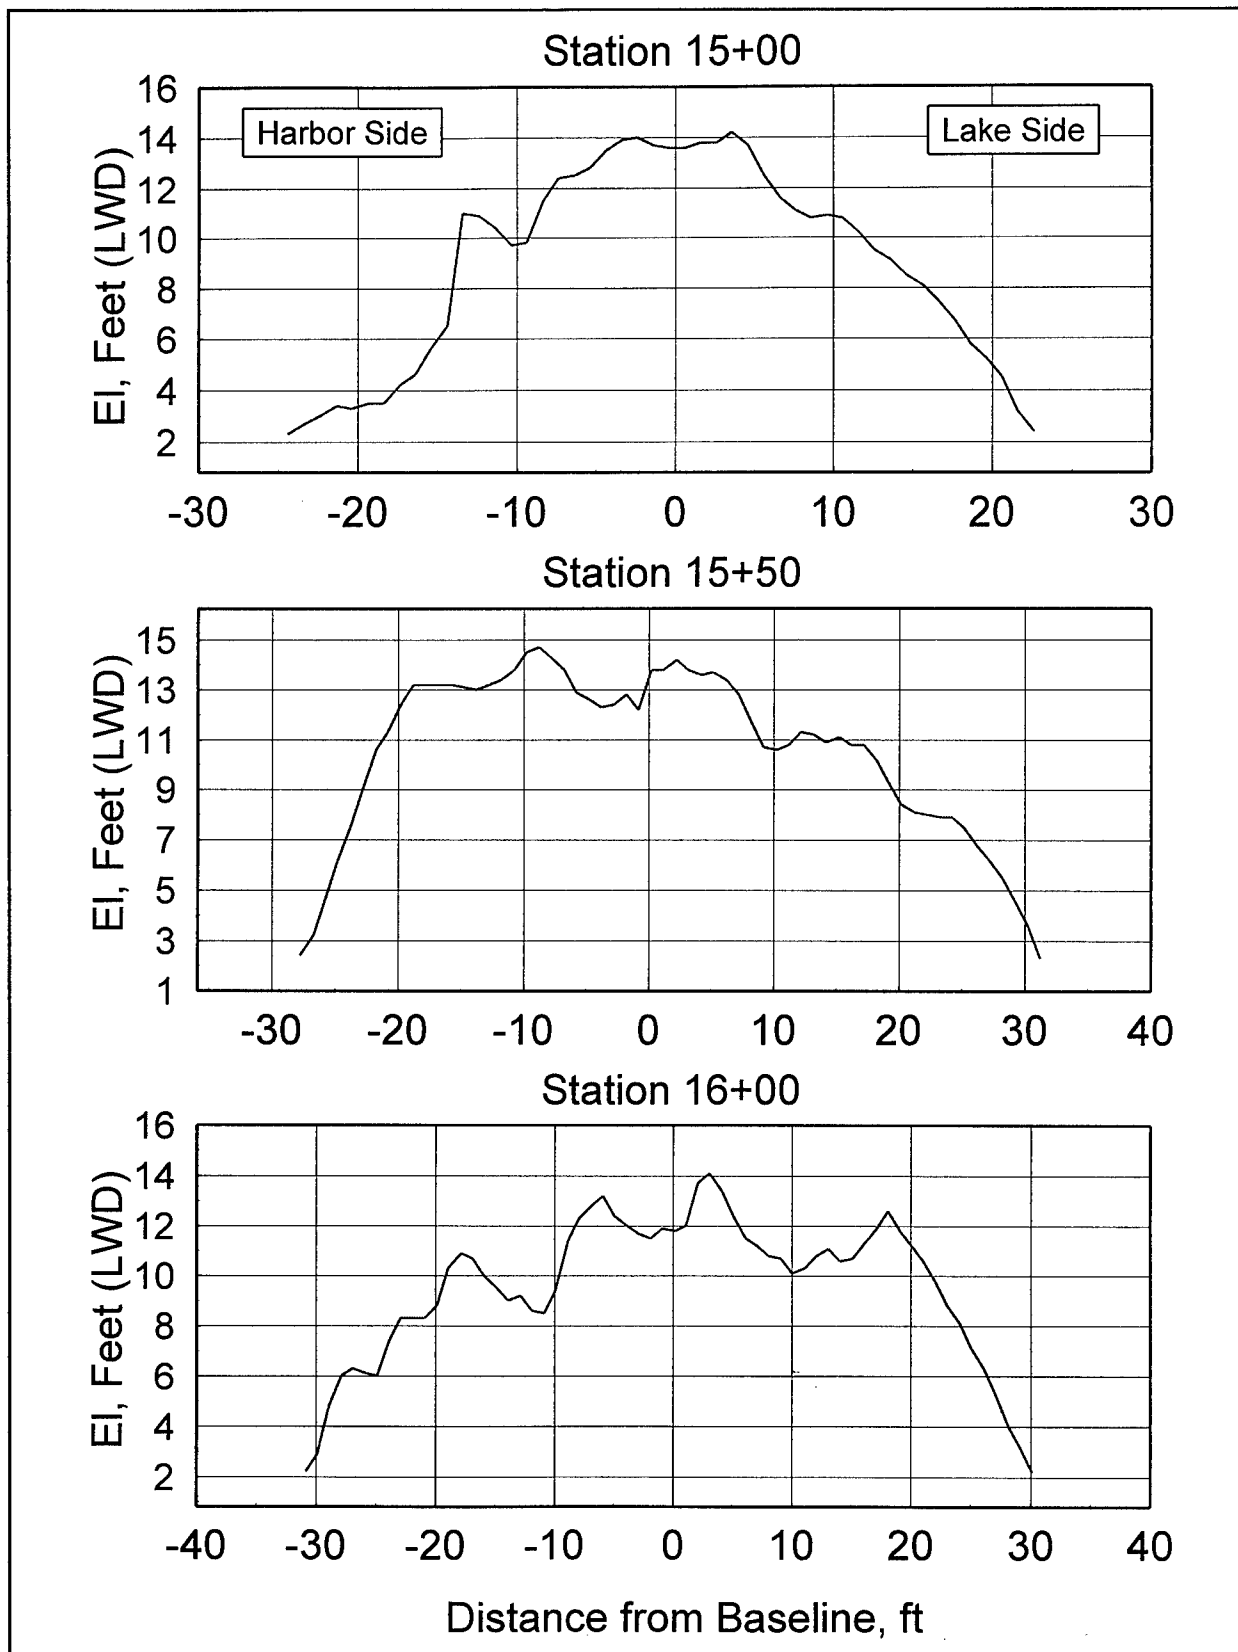
Figure B15. Cross sections of Burns Harbor North Breakwater, sta 15+00, 15+50, and 16+00

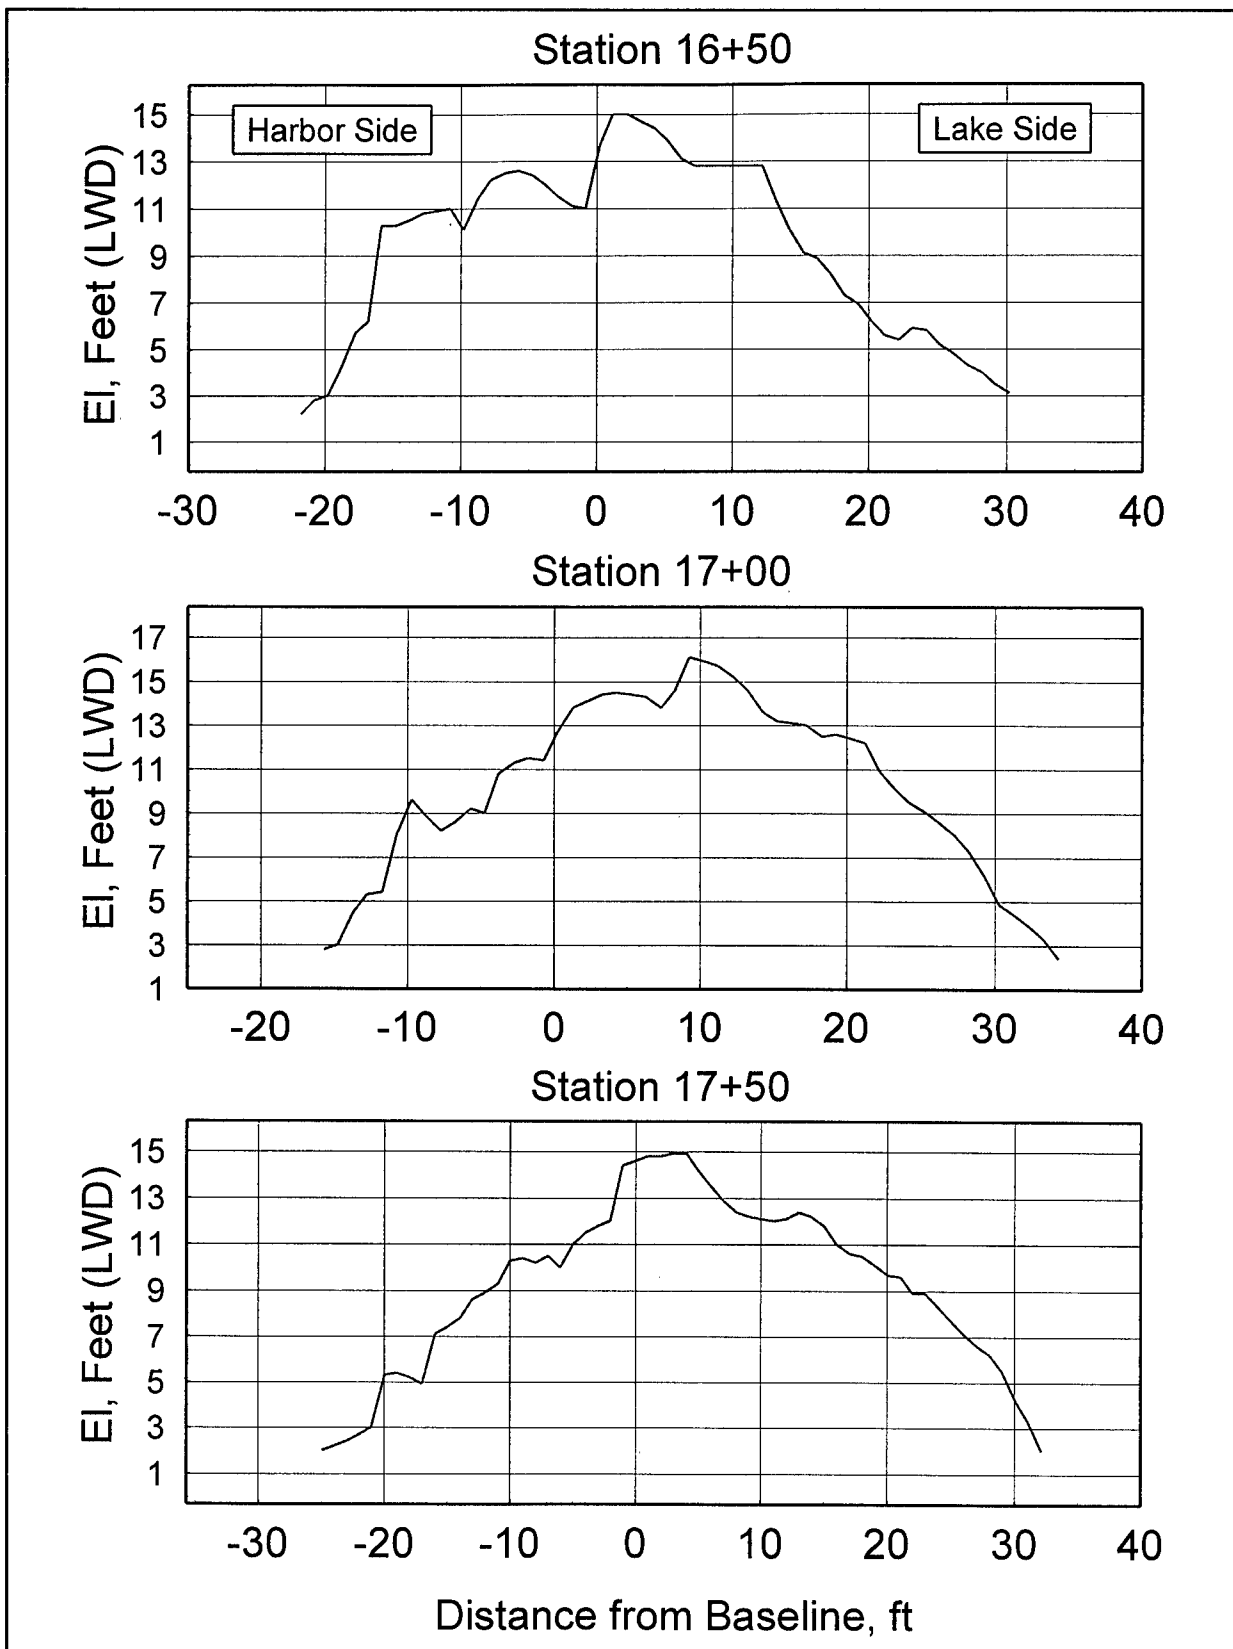
Figure B16. Cross sections of Burns Harbor North Breakwater, sta 16+50, 17+00, and 17+50

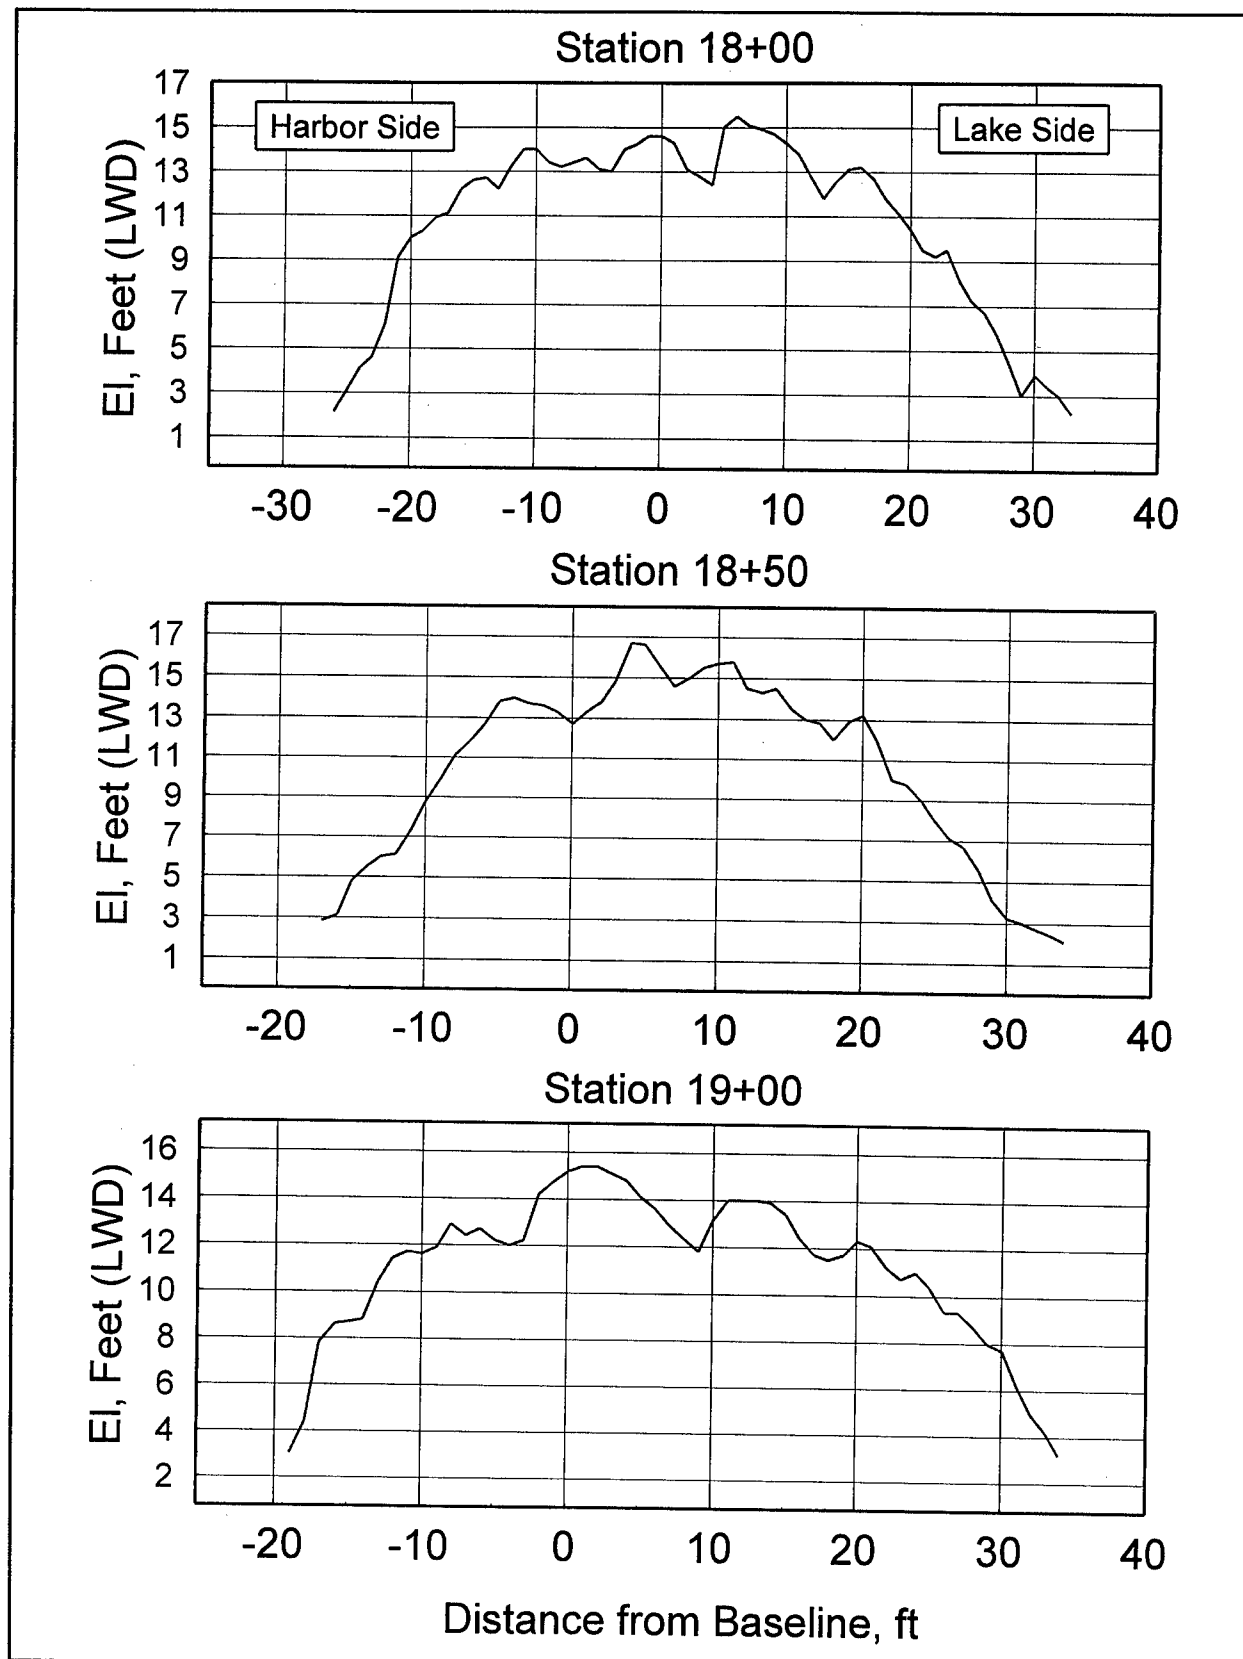
Figure B17. Cross sections of Burns Harbor North Breakwater, sta 18+00, 18+50, and 19+00

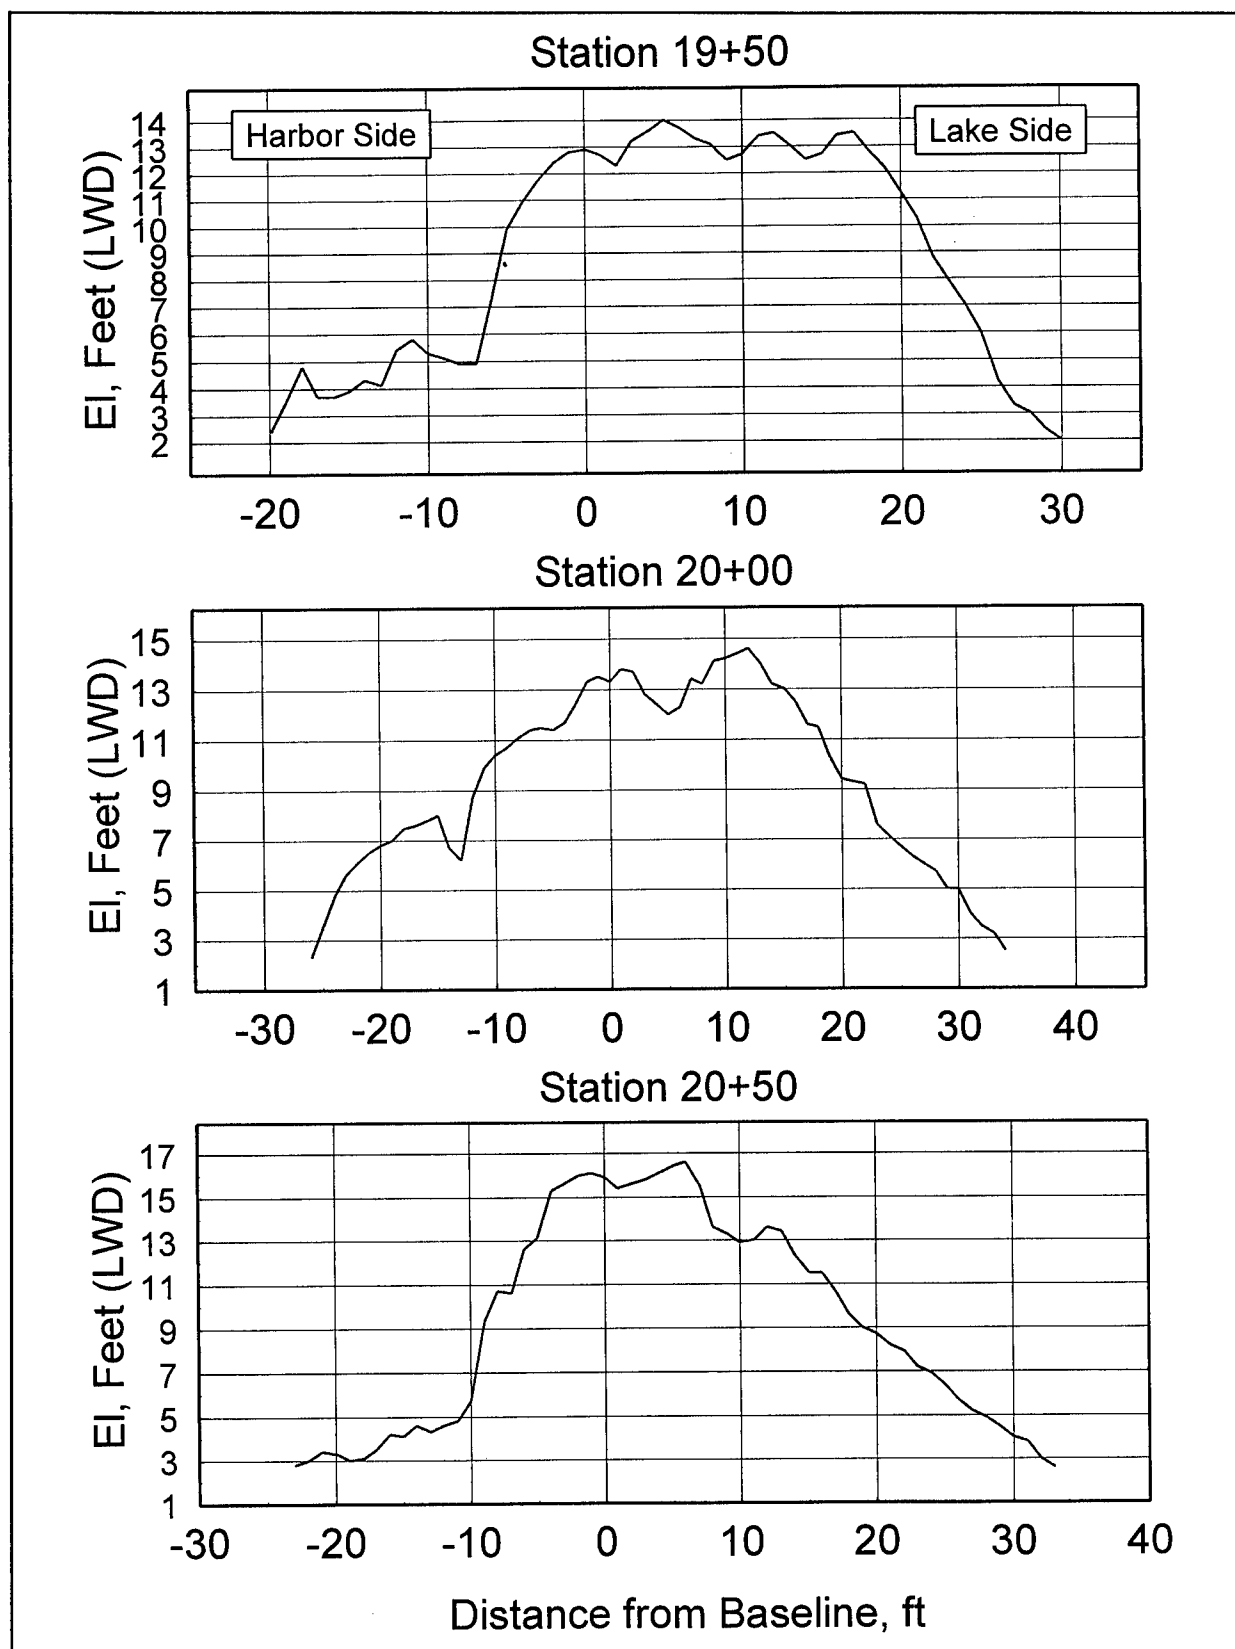
Figure B18. Cross sections of Burns Harbor North Breakwater, sta 19+50, 20+00, and 20+50
